HORTON LAKE DAM

NDI No. PA 00070
PennDER No. 58-124
Dam Owner: Harry Horton

PHASE I INSPECTION REPORT
NATIONAL DAM INSPECTION PROGRAM

Horton Lake Dam, Susquehanna County, Pennsylvania
NDI No. PA 00070, PennDER No. 58-124
Sterling Brook
Inspected 30 October 1980

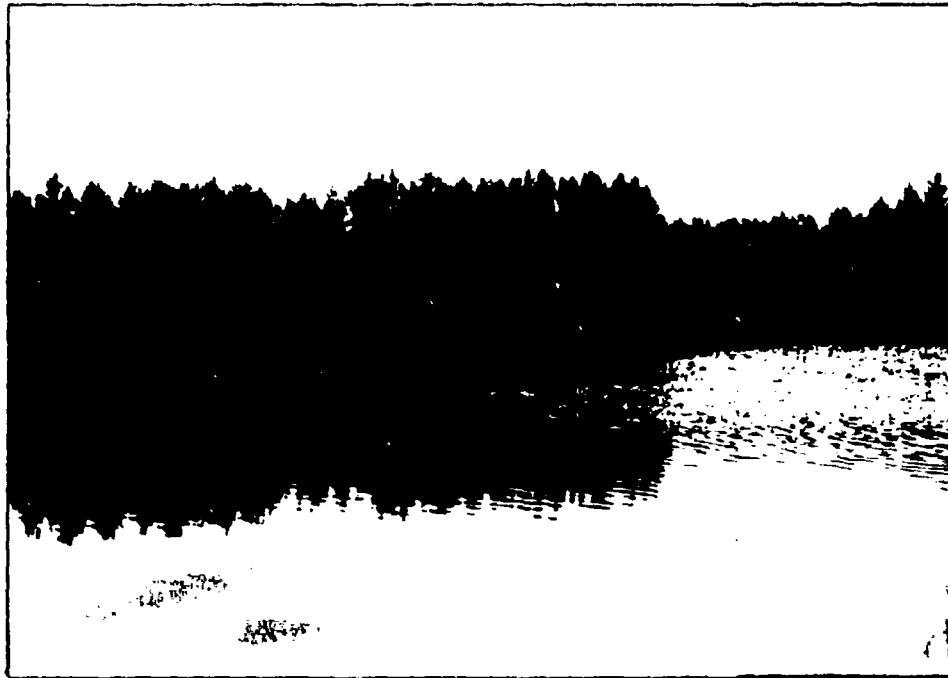
PHOTO 1. View of Upstream Slope of Dam from Left Shoreline

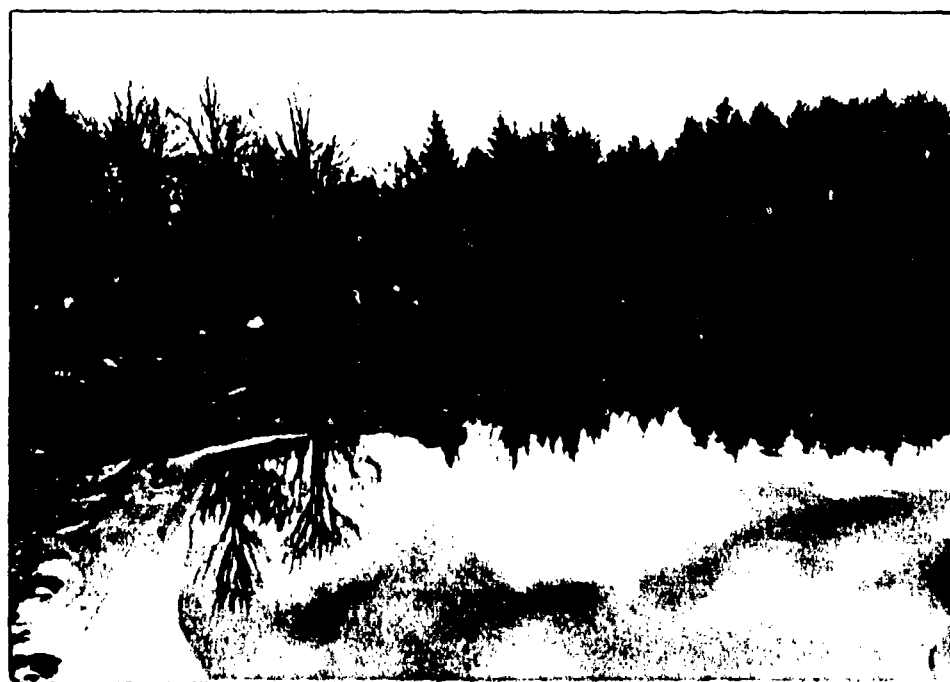
PHOTO 4. View of Spillway Approach

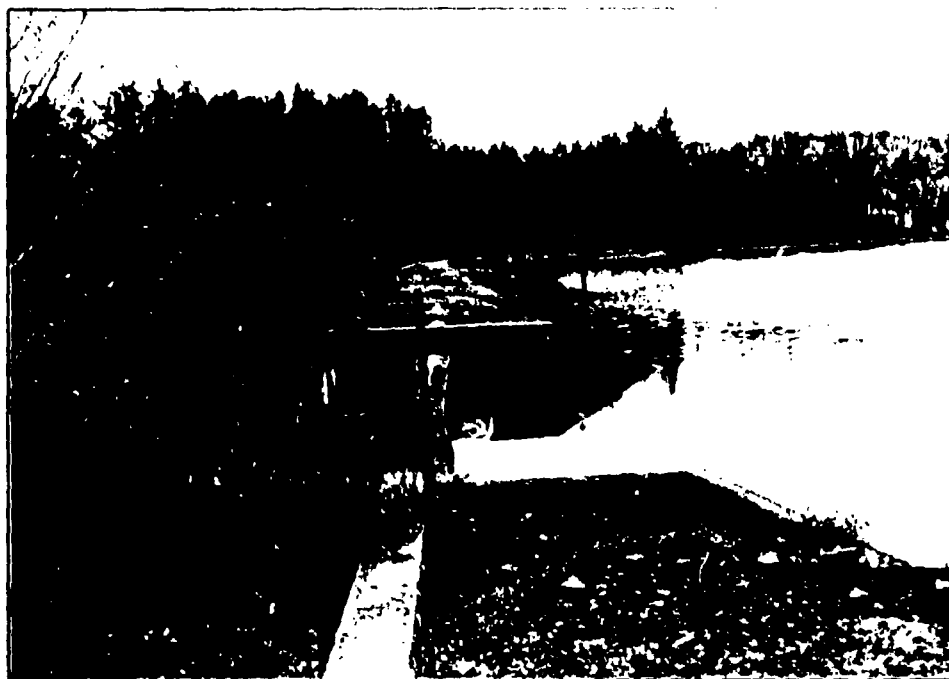
PHOTO 5. View Across Crest of Spillway
